TO 1F-15C-3-2

Figure 3-55. Main Structure (Sheet 1 of 7)

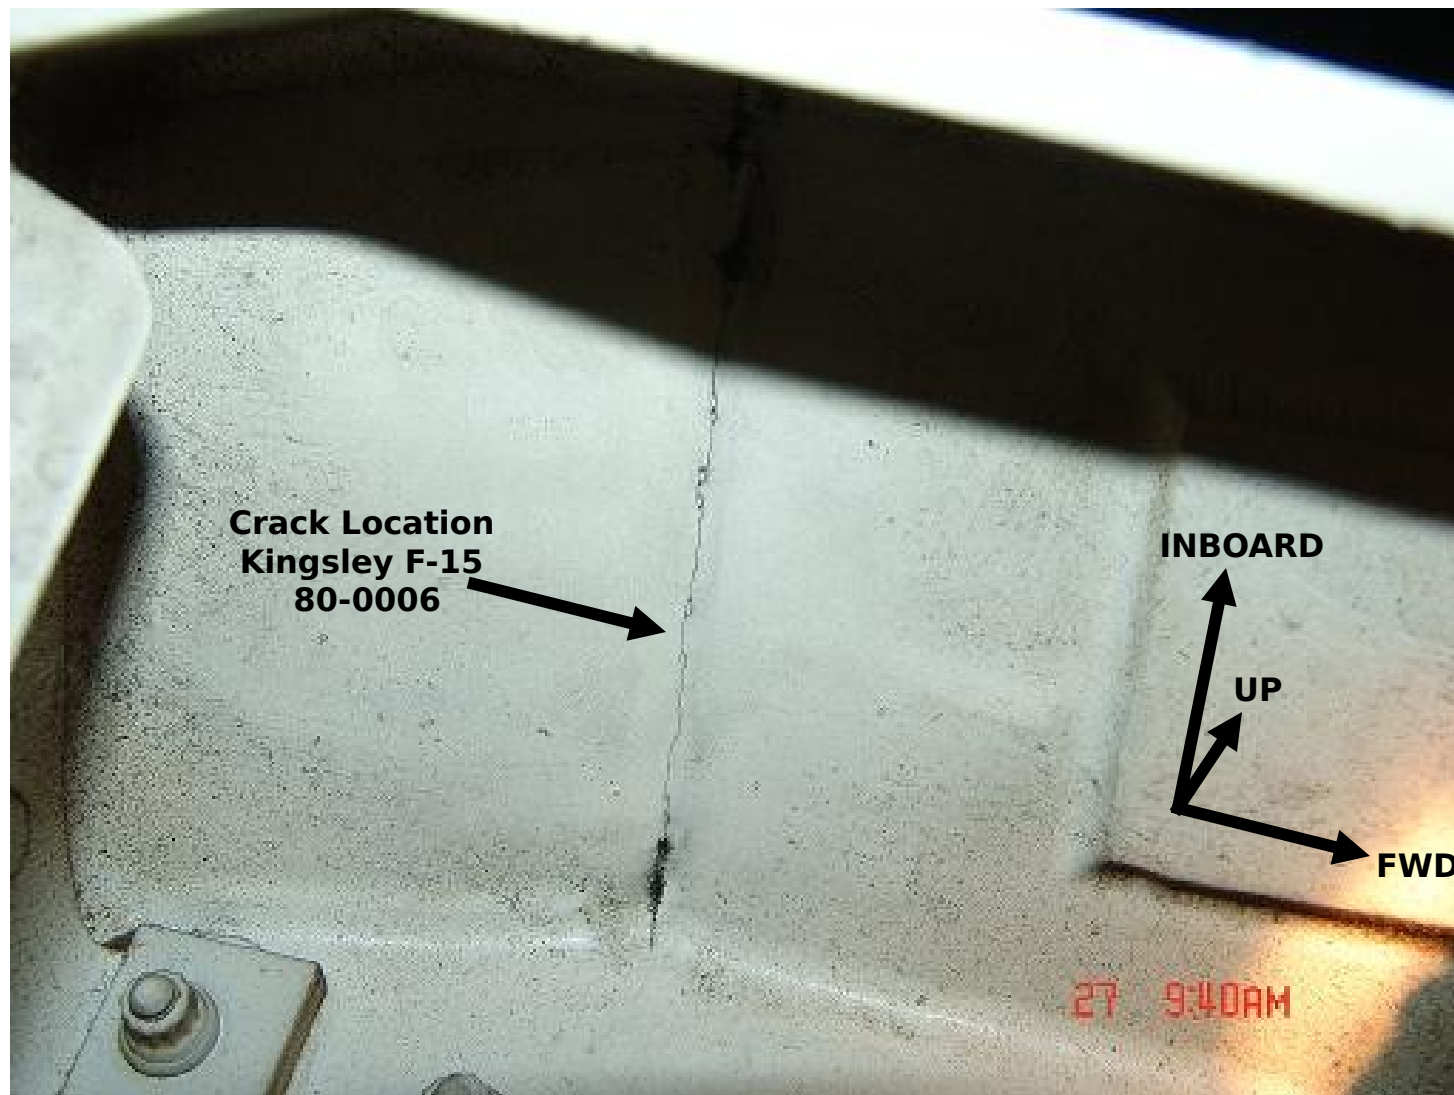
Accident Aircraft Fatigued Longeron

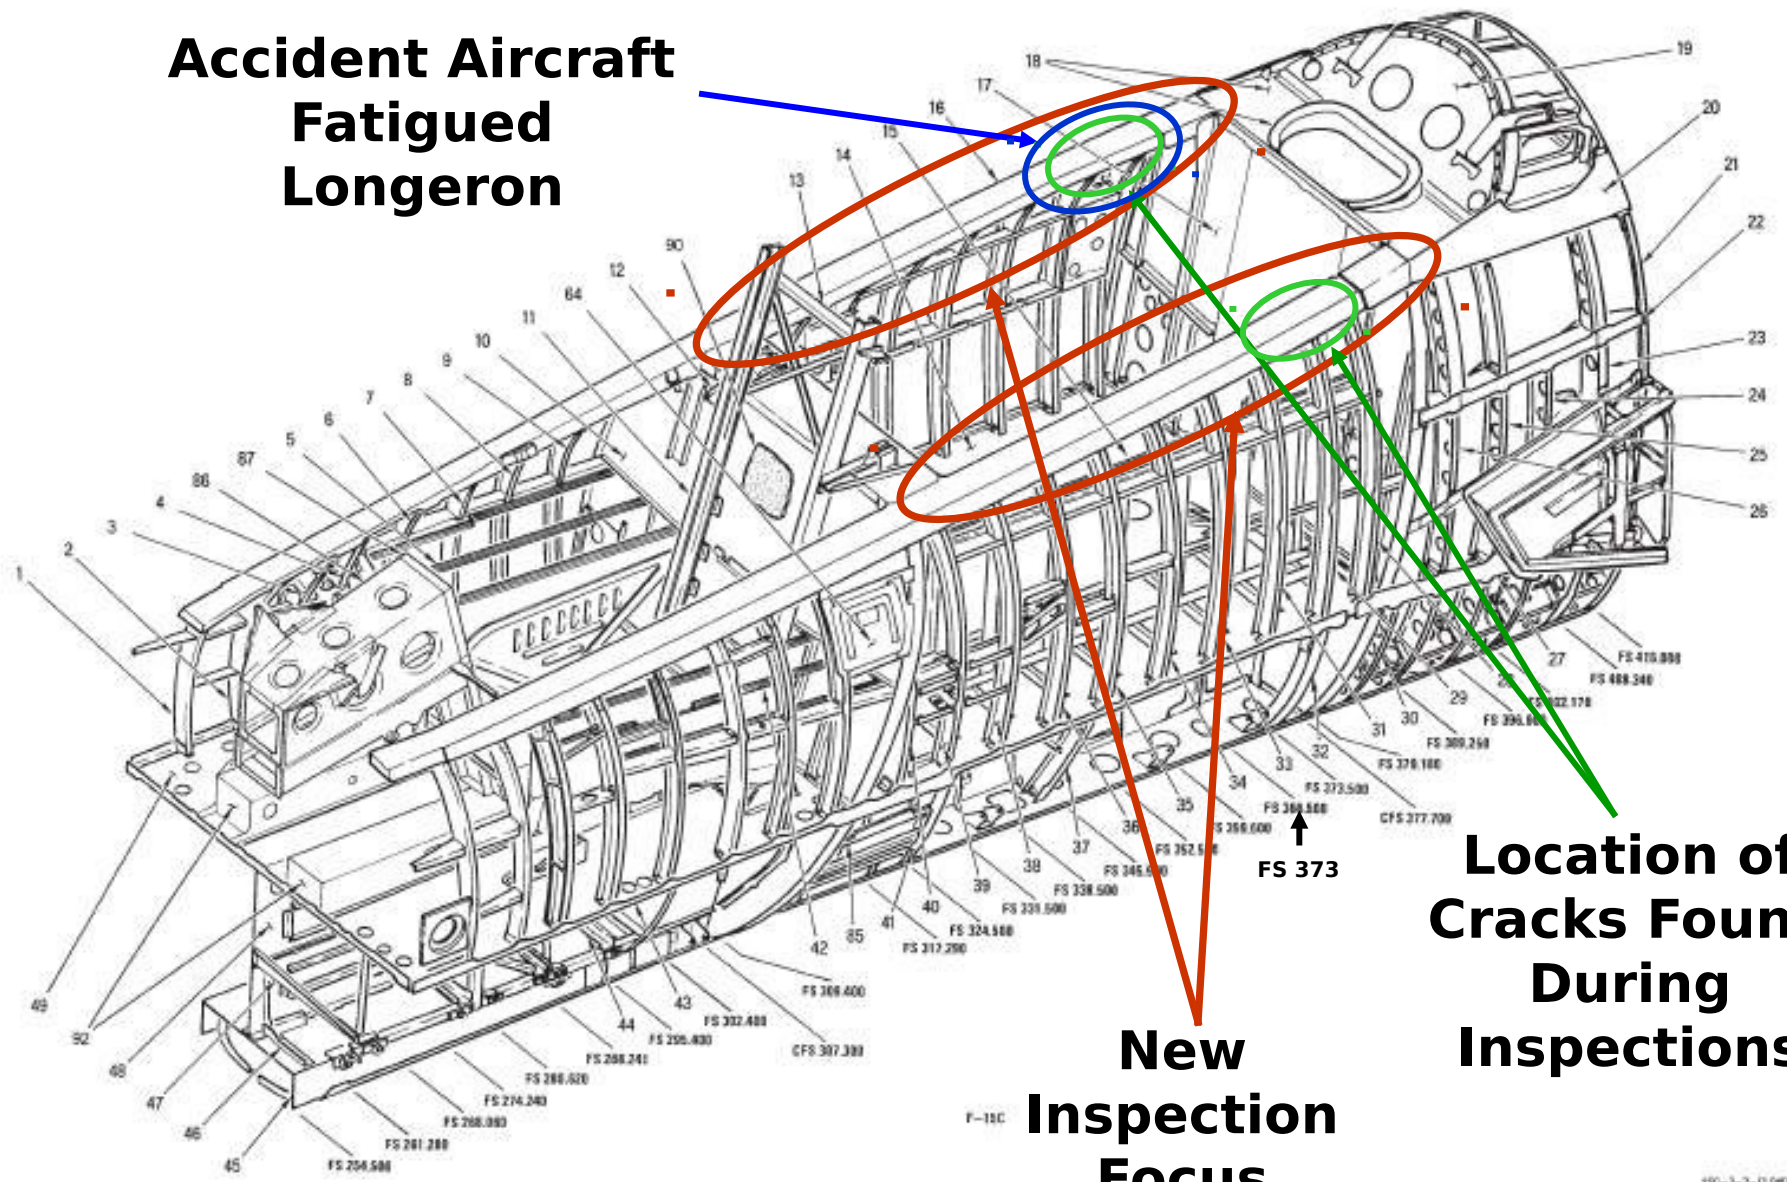
Figure 3-55. Main Structure (Sheet 1 of 7)

**Location of
Cracks Found
During
Inspections**

**New
Inspection
Focus**

New Inspection Area Two Seat F-15 (Typical Left & Right Side)
